# P25 Coverage Mapping of a Shopping Mall

This white paper details the process and equipment used for conducting a signal strength survey of a public safety radio system within a large shopping mall. CSI Telecommunications, Inc. of Novato, California commissioned this survey. The project involved the utilization of an Anritsu S412E LMR Master in conjunction with the TRX Neon In-building mapping software. The objective was to comprehensively map the P25 coverage inside the shopping mall.

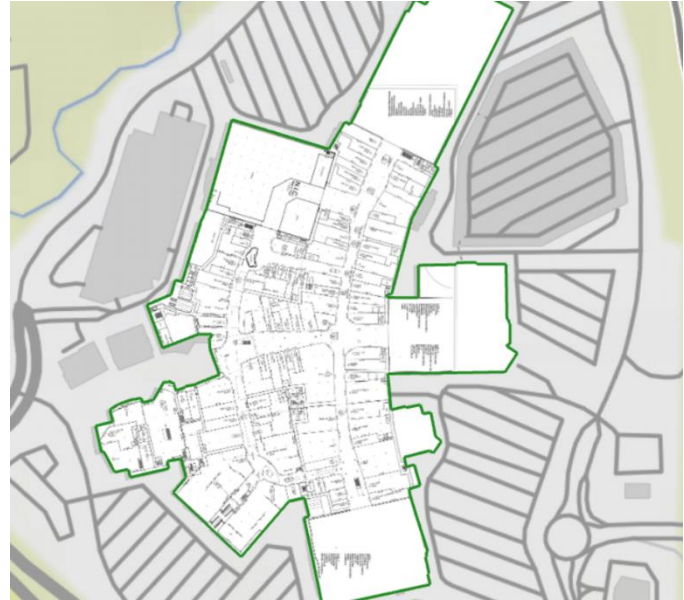
*Shopping mall floor plan overlaid on the street map for mall*

- The survey team employed an Anritsu S412E spectrum analyzer along with the TRX Neon In-building mapping software.
- The Neon Command PC software was used to overlay the floor plan map precisely on the street map for the mall.
- A cart was used to mount the equipment.
- A unity gain receive antenna, positioned just above head level, minimized shadowing from the surveyors' bodies.

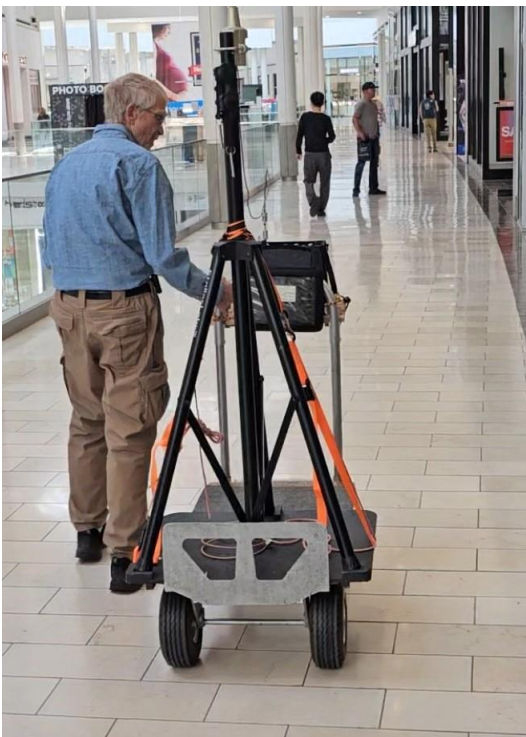
*Cart to hold equipment and unity gain antenna above our heads*

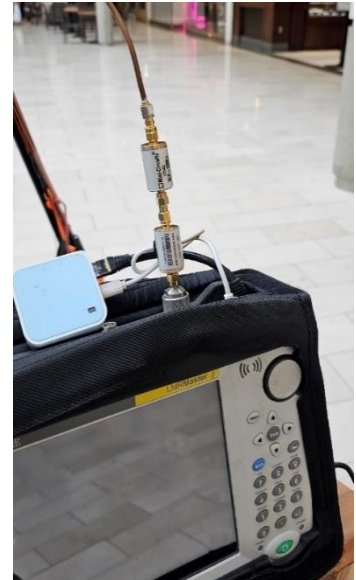
Bandpass (Minicircuits high and low pass filter)

- To reduce interference from Wi-Fi and cellular signals, a bandpass filter was placed between the antenna and the Anritsu S412E.
- The filter's loss and cable characteristics were taken into account by entering this information into the S412E's offset menu.

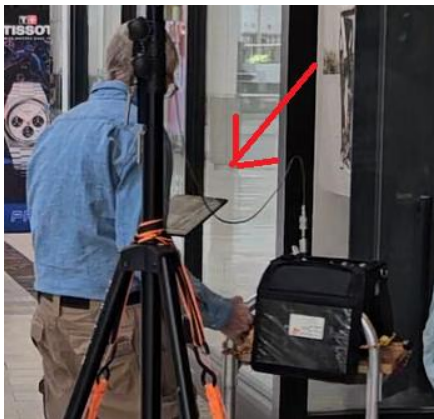
Android tablet running Neon software

- The TRX Neon system utilized an Android tablet to display the mall's floor plan and measurements as the surveyors walked.
- Measurements included RSSI (Received Signal Strength Indicator), BER (Bit Error Rate), Mod Fidelity, and SINR (Signal-to-Interference plus Noise Ratio).
- Surveyors could customize the data displayed on the tablet during the walk.
- The Neon Command PC software allowed further customization of the summary map reports.

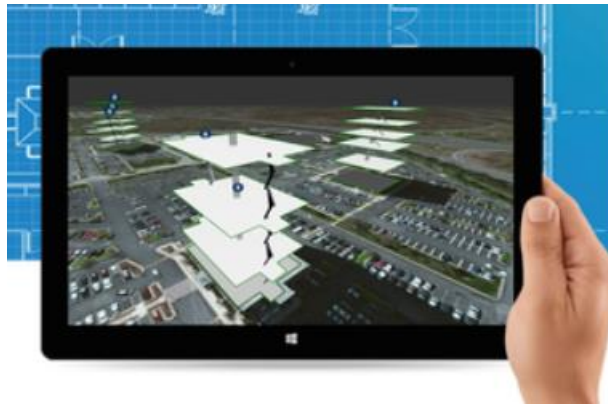
-68 dBm RSSI as we started mapping

- The Anritsu S412E was configured to measure the control channel signal of the trunked P25 system.
- The P25 system was simulcast so the S412E was set to use the CQPSK demodulator. The display on the S412E showed 0 MER (Modulation Error Rate) and FER (Frame Error Rate).
- Measurements commenced at an RSSI level of -68 dBm.

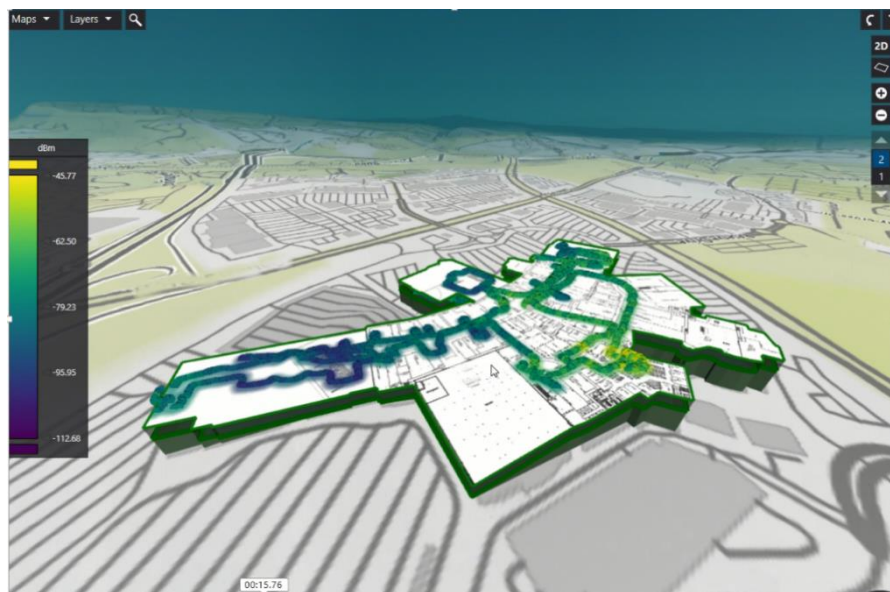
*Neon Command 3D display of measurements showing good coverage on the second floor*

**Floor 2**  
10/2/2023  
Grids Tested: 86  
Passing Grids: 84 (98%)  
Result: **PASS**  
**Anritsu SPA and LMR**  
P25  
Receiver Frequency:  
352 MHz  
Direction: DL  
**Received Power**  
dBm  
0.00  
-95.00  
-120.00  
Generated by NEON

The survey effectively mapped the P25 coverage within the shopping mall, with the vast majority of grid squares meeting the required RSSI levels. This successful endeavor was made possible by the collaboration of the survey team, and special thanks go to Toan Vo of Anritsu for assisting with the TRX Neon software setup and Bill Ruck of CSI Telecommunications for aiding with the cart setup and measurements.

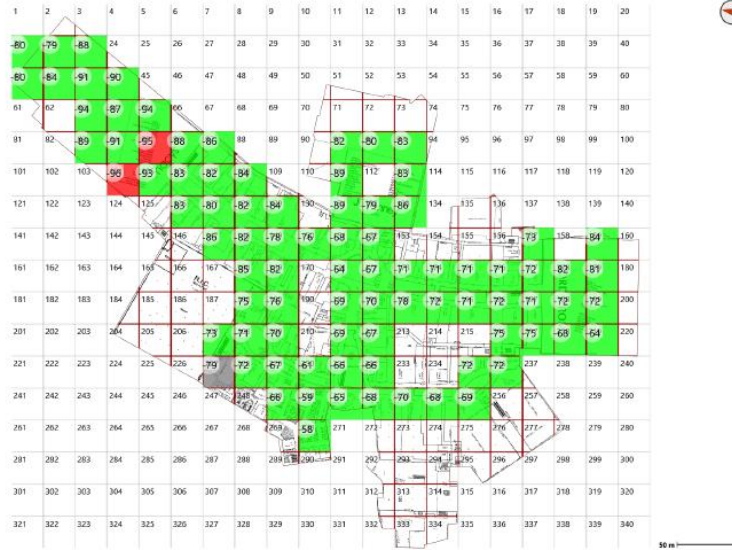
### Grid Statistics

Grids Tested: 86  
Passing Grids: 84 (98%)  
Result: **PASS**

*Our measurements showed passing RSSI levels in all but a few locations.*
